FLOODPLAIN WETLANDS

Grindstone Estuary Fact Sheet prepared by Tys Theysmeyer, Noel Boucher, and Shari Faulkenham. Published by Royal Botanical Gardens.
Thanks to: Len Simser.

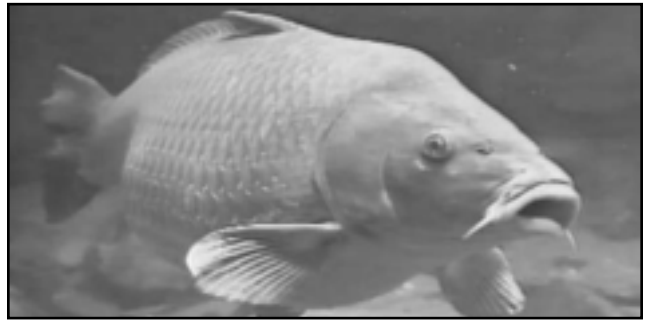
The common carp's bottom foraging behaviour can result in massive marsh vegetation destruction.

The common carp (*Cyprinus carpio*) is native to Asia, and is adapted to a river mouth marsh environment. Carp forage by rooting through the soft bottom for clams, snails, and insect larva. This foraging resuspends the bottom sediment, muddying the water, and uprooting aquatic plants (see *Fishway Fact Sheet*).

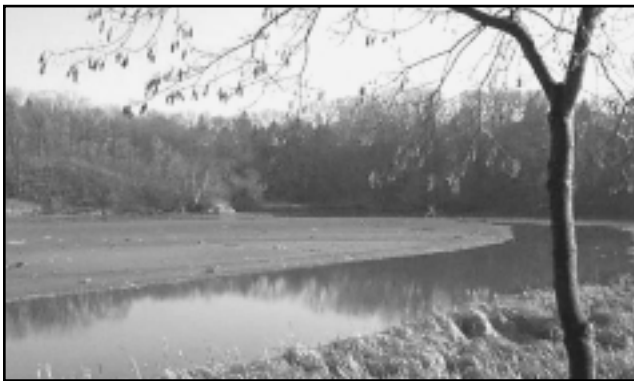
Annual fall low water levels reveal the remains of the channel, and the desolate exposed mudflats.

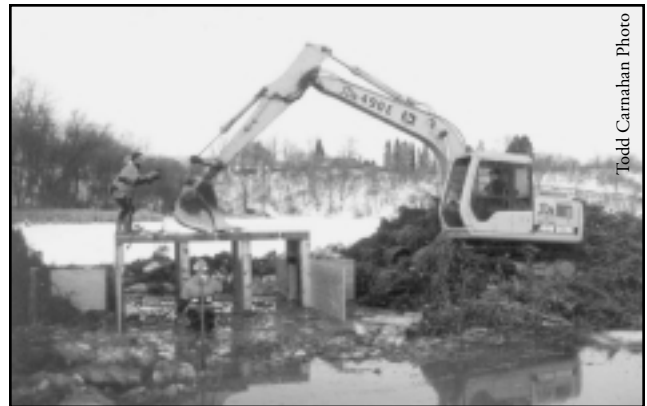
The water and fish control structure is installed in the Sunfish Pond Christmas tree enclosure.

Near the upstream end of each rehabilitation site, input structures were installed to allow floodwater from the creek to enter into the floodplain. This took the form of an excavated channel fitted with a culvert to solidify the channel under the continued passage of water. The installed culvert contained built-in fish exclusion grates to restrict the passage of fish wider than five centimeters, targeting all adult carp.

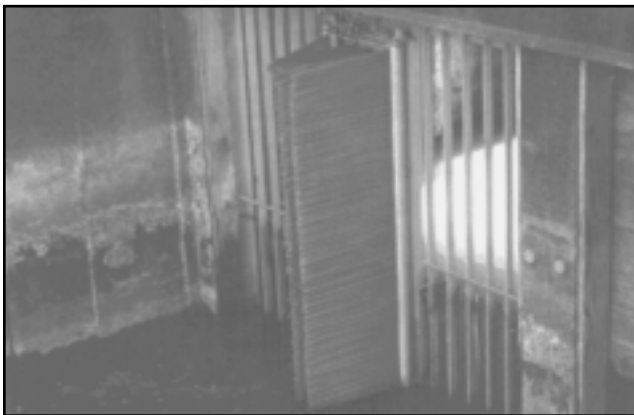
This structure can be opened to allow native fish into the floodplains, then closed to exclude carp later on.

At the downstream end of each floodplain, a structure developed by RBG, dubbed the FENCE (Floodplain Enhancement Node and Carp Excluder) was installed to function as a controlled passage for water and fish into and out of the floodplain. Water will most often flow out of this structure, except during lake seiche effects when rising lake levels will cause water to flow into these structures, replenishing the marshes of the lower estuary. The volume of water capable of leaving this structure is greater than that entering the upstream culvert, therefore preventing floodwaters from exceeding the height of the elevated riverbanks.

The FENCE consists of grates that restrict access to fish wider than five centimeters, targeting all adult carp. A pivoting brush system in the centre provides a unidirectional passage out for larger fish that are restricted by the grates, while preventing carp from entering the marsh.

In early spring, the brushes, oriented to the creek-side of the structure, are opened, allowing large fish to pass through. Native fish such as northern pike and bowfin, as well as smaller species such as yellow perch, black crappie and golden shiner, all spawn in the productive environment of floodplain ponds early in the season. In early April, before carp begin their spawning migration, the brushes are closed to a wedge shape, thus preventing the passage of large fish into the floodplain. Any large fish that still remain in the floodplain are able to exit into the creek by pushing through the flexible brushes from the inside. The brushes immediately close once the fish swims out into the creek, maintaining the exclusion of carp.

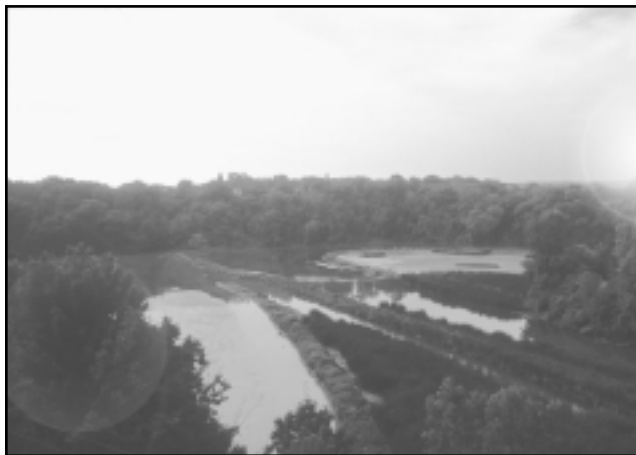
The newly defined banks of the creek isolate Osprey Marsh to the left and Blackbird Marsh to the right.

The construction of new riverbanks in the lower Grindstone area resulted in the creation of three newly defined floodplain marshes: Blackbird Marsh, Osprey Marsh, and Sunfish Pond. Vast improvements in water quality have since been realized. With continued carp exclusion, the gradual recolonization of these marshes with vegetation will provide for the recovery of native fish and wildlife populations.

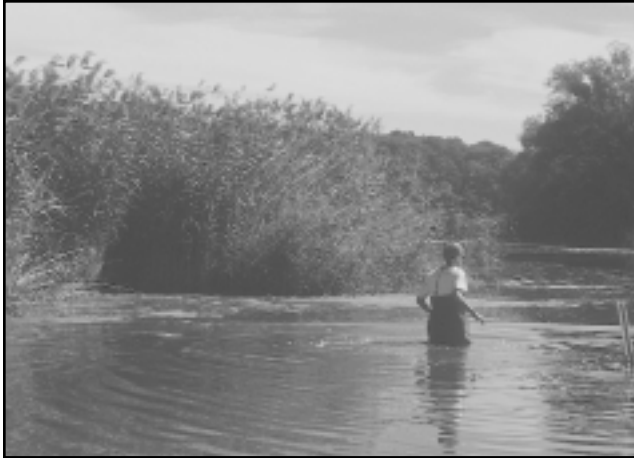
Vegetation monitoring is conducted to determine the extent and diversity of the new plant growth.

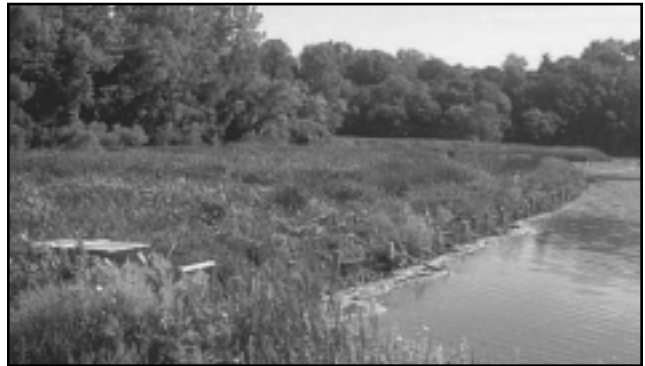
New aquatic plant growth covered the entire area within the pilot-scale Christmas tree berm in Blackbird Marsh.

In 1999, a pilot Christmas tree berm project was implemented in a small region of Blackbird Marsh to determine if it would be an effective restoration technique. An astonishing increase in emergent plant densities resulted in the marsh, evolving from a barren mudflat into a completely vegetated system inhabited by giant burreed, softstem bulrush, and cattails. The success of the pilot project led to the full-scale implementation of the project the following year.
