Impact to Cootes Paradise Marsh associated with Chedoke Creek spill of 2014-2018

Tys Theijsmeijer
Natural Lands Department
Royal Botanical Gardens
February 20, 2021

Executive Summary

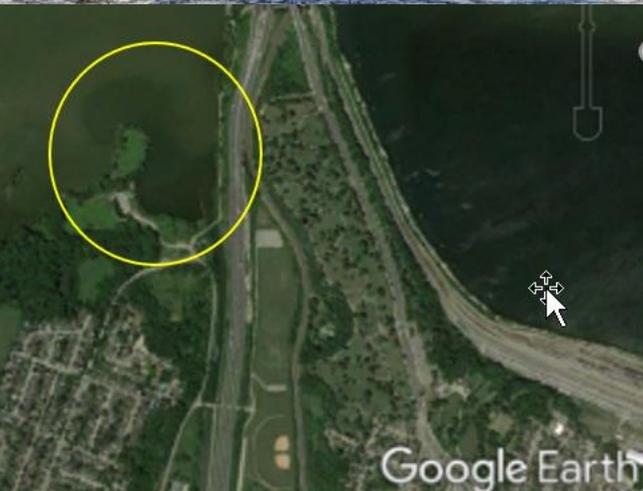
Chedoke Creek below Hwy 403 box culvert - Tys Theijsmeijer, July 3, 2018

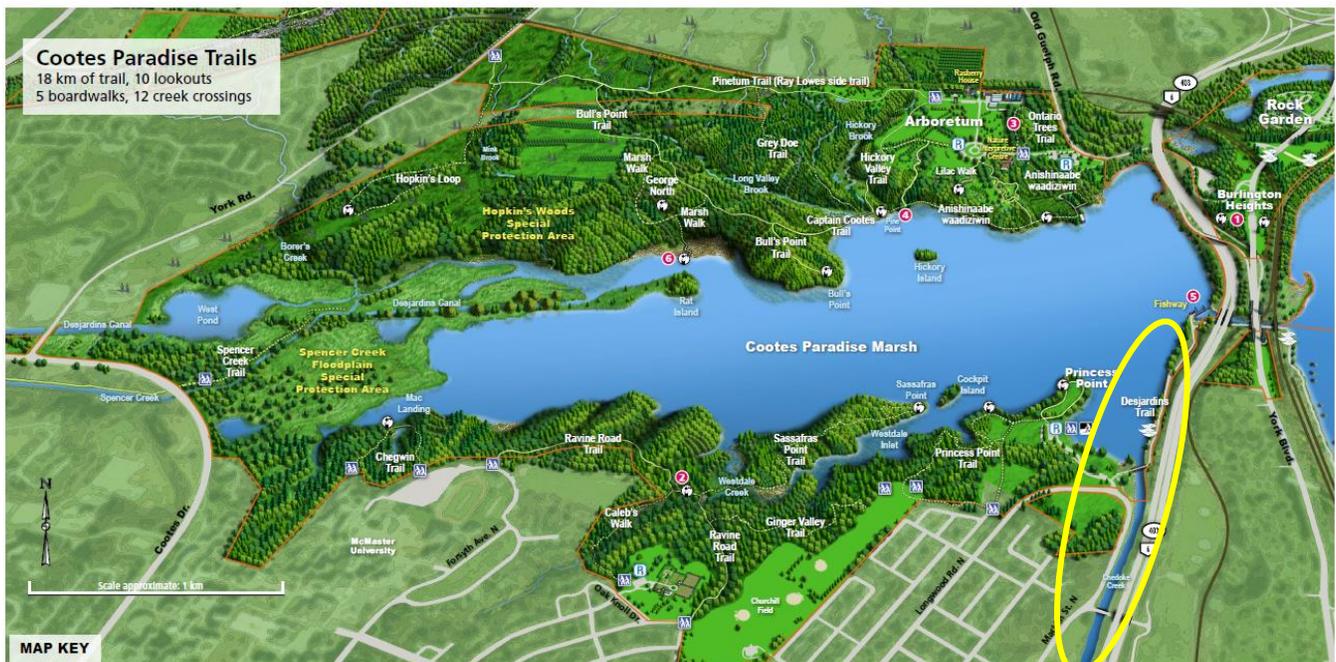
Figure 1. Map of Royal Botanical Gardens Cootes Paradise Property and the area of Chedoke Inlet adjacent to Princess Point Bay

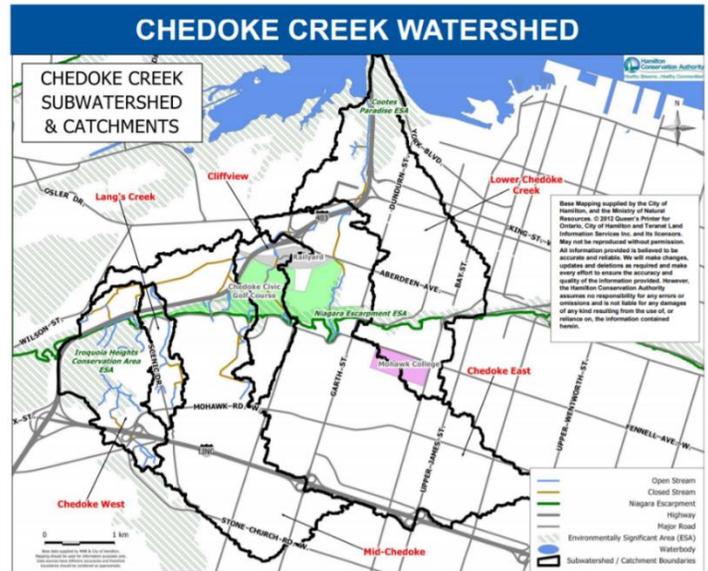
Map courtesy Hamilton Conservation Authority, online 2018 Stewardship Factsheet regarding Chedoke Creek.

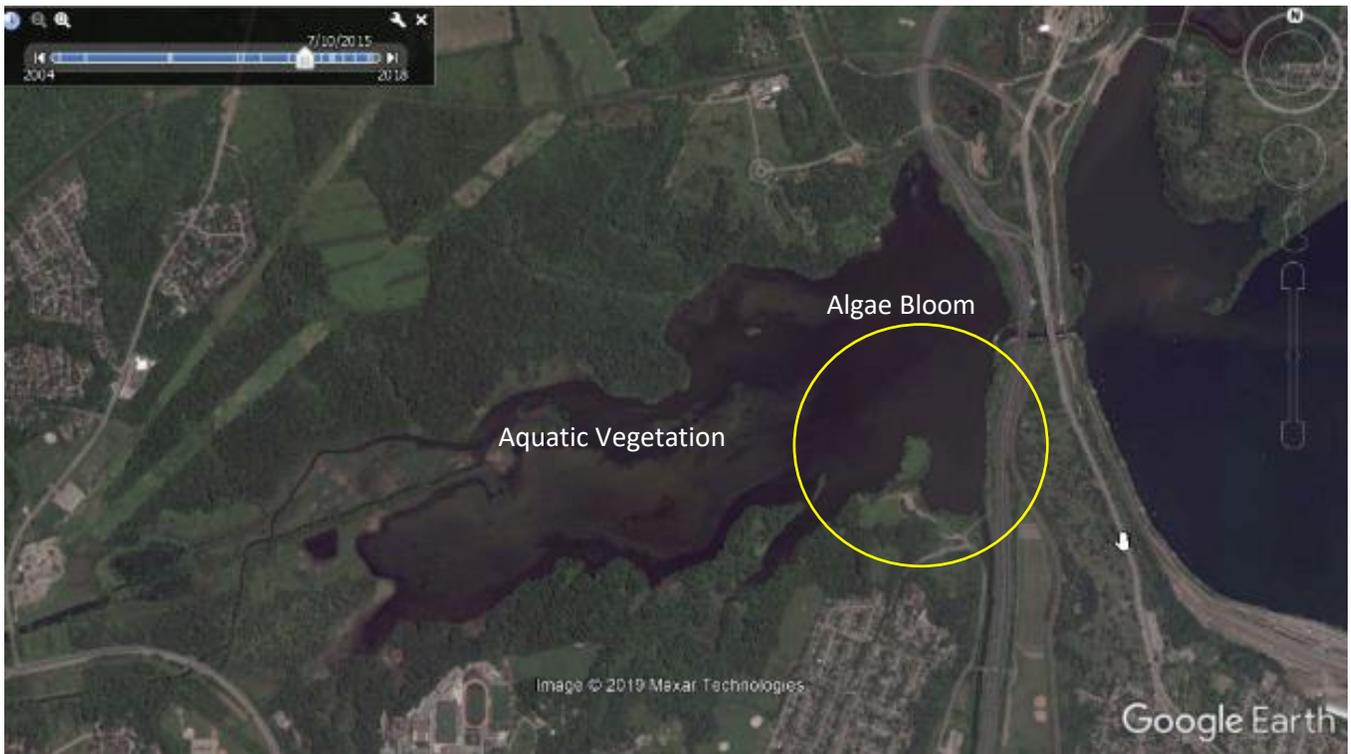
Figure 2. July 10, 2015 Google Earth aerial photo (Photo used in RBG Wetlands Restoration Plan, 2016-2021). Marsh clear and with aquatic plants (other than algae bloom in waters downstream of Chedoke Creek).

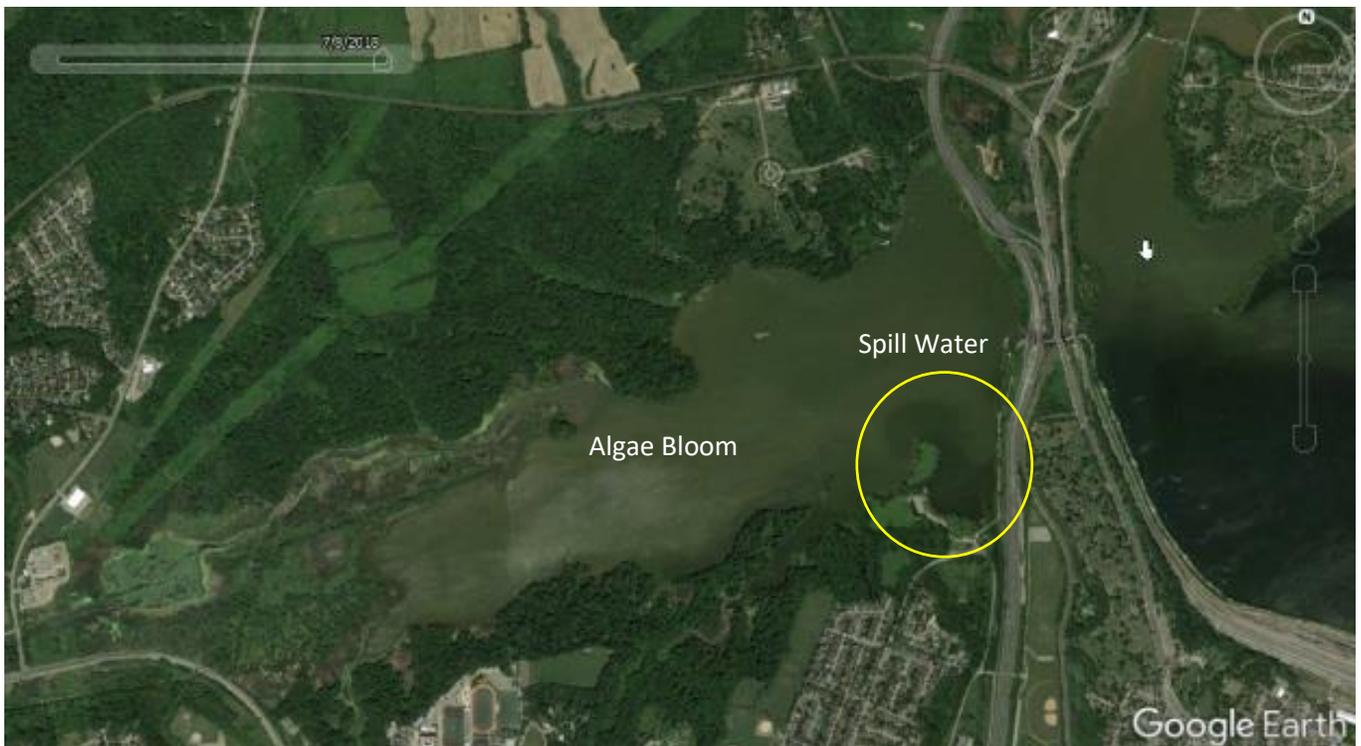
Figure 3. July 7, 2018 Google Earth aerial photo – all Cootes Paradise is an algae bloom as water mixes; unmixed Chedoke inflow is notable by Princess Point.

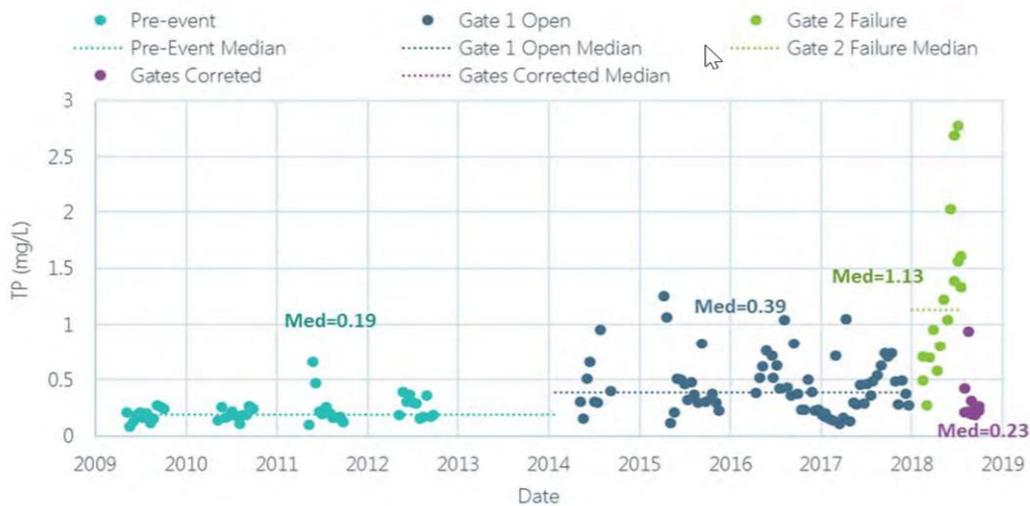
Figure 4-12: CP-11 TP Scatterplot with Medians for Event Time Periods

Figure 4. Lower Chedoke Creek Inlet of Cootes Paradise Marsh total phosphorus result. Results pre-2009 are reflective of all other years of monitoring data, with previous summary in RBG 2012 Water Quality trends report. All samples are substantially poorer than Provincial and Federal Water Quality Guidelines for Aquatic Life with 2018 essentially raw sewage.

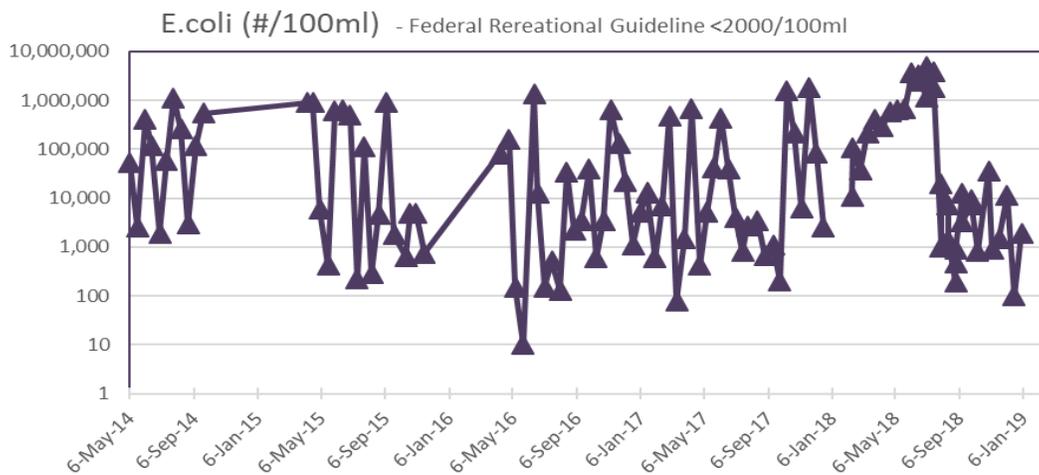
Figure 5. HCA monitoring data, lower Chedoke Creek inlet at Kay Drage bridge crossing. Information courtesy Hamilton Conservation Authority through the HHRAP partnership and Cootes Paradise Water Quality Committee.

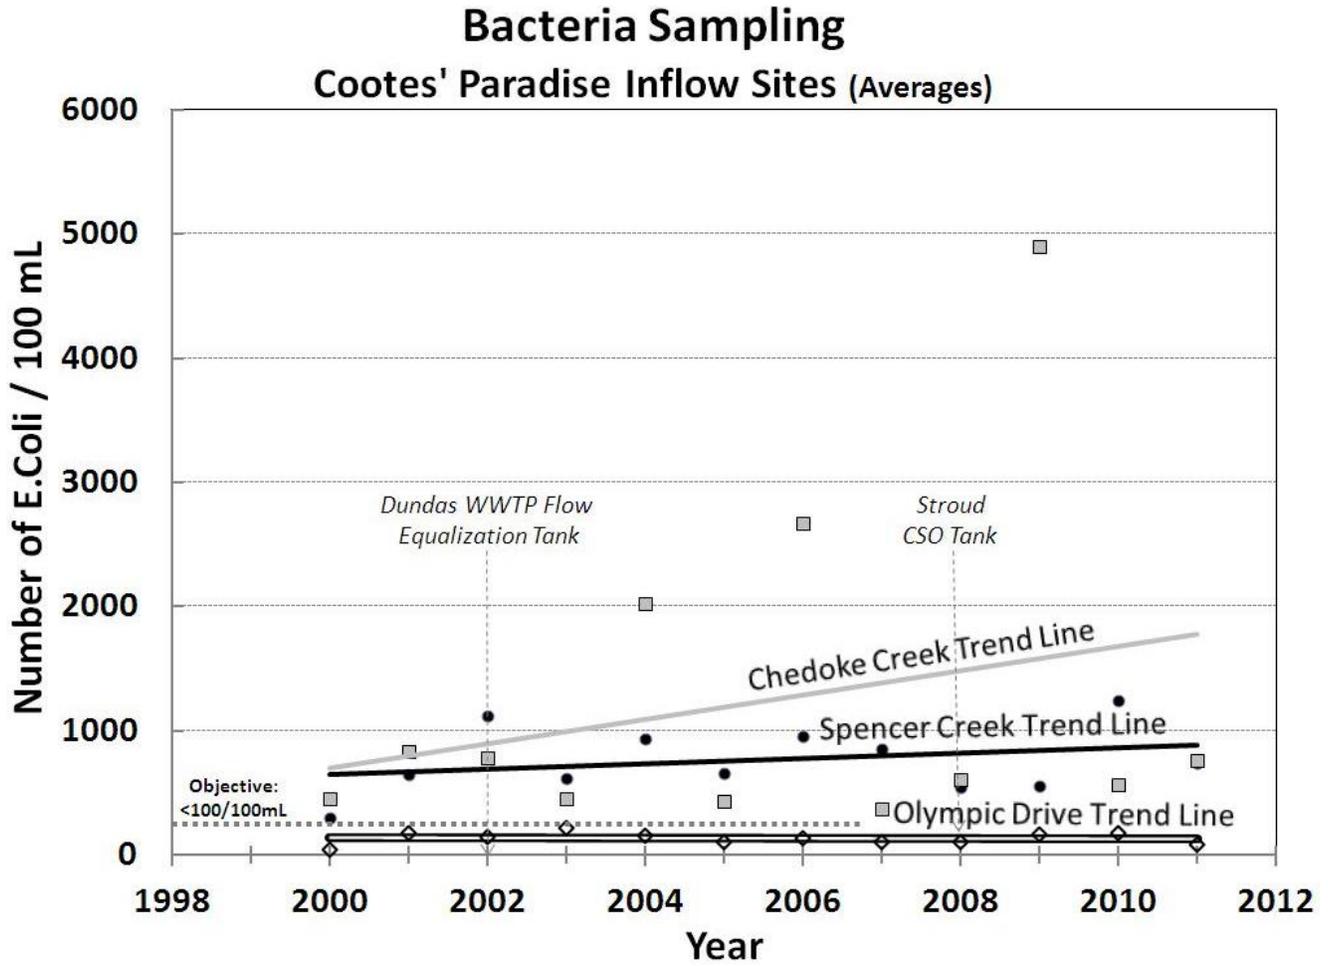
Figure 6. Lower Chedoke Creek Water Quality highlights, Royal Botanical Gardens 2012 Water Quality report (available online within the RBG website).

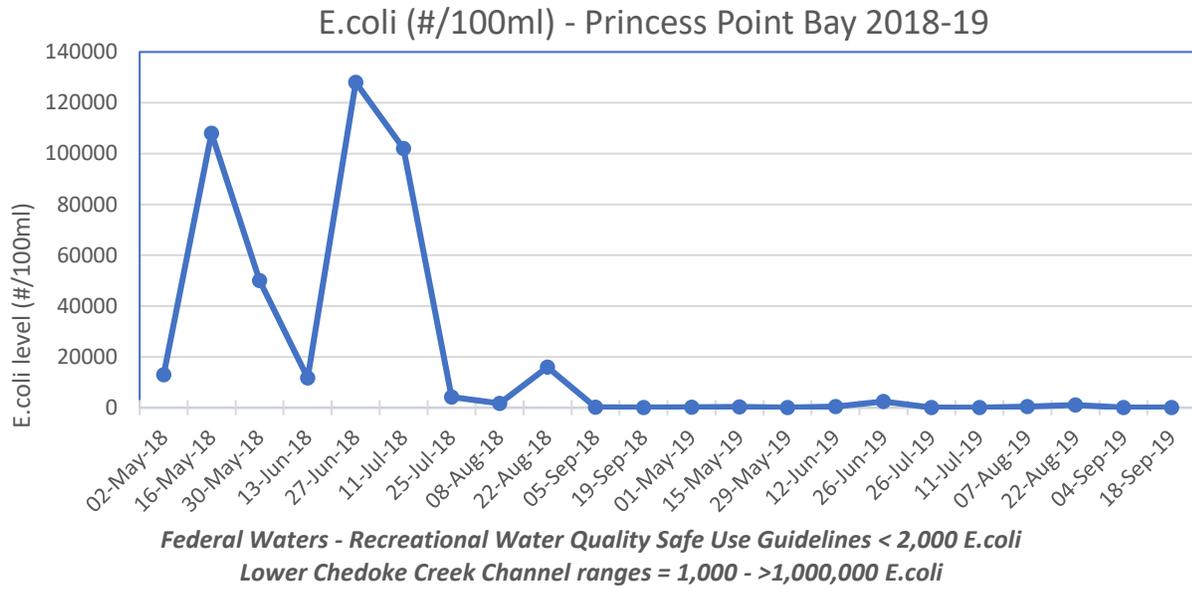
Figure 7. E.coli Monitoring Results 2018-2019 Princess Point Bay. Sampling is a project associated with a Chedoke waters diversion berm assessment, with the first section of berm installed in February 2018. The waters are reflective of conditions at the adjacent RBG public canoe launch. Since Sept 2018 all samples have tested below 2000 E.coli/100ml.

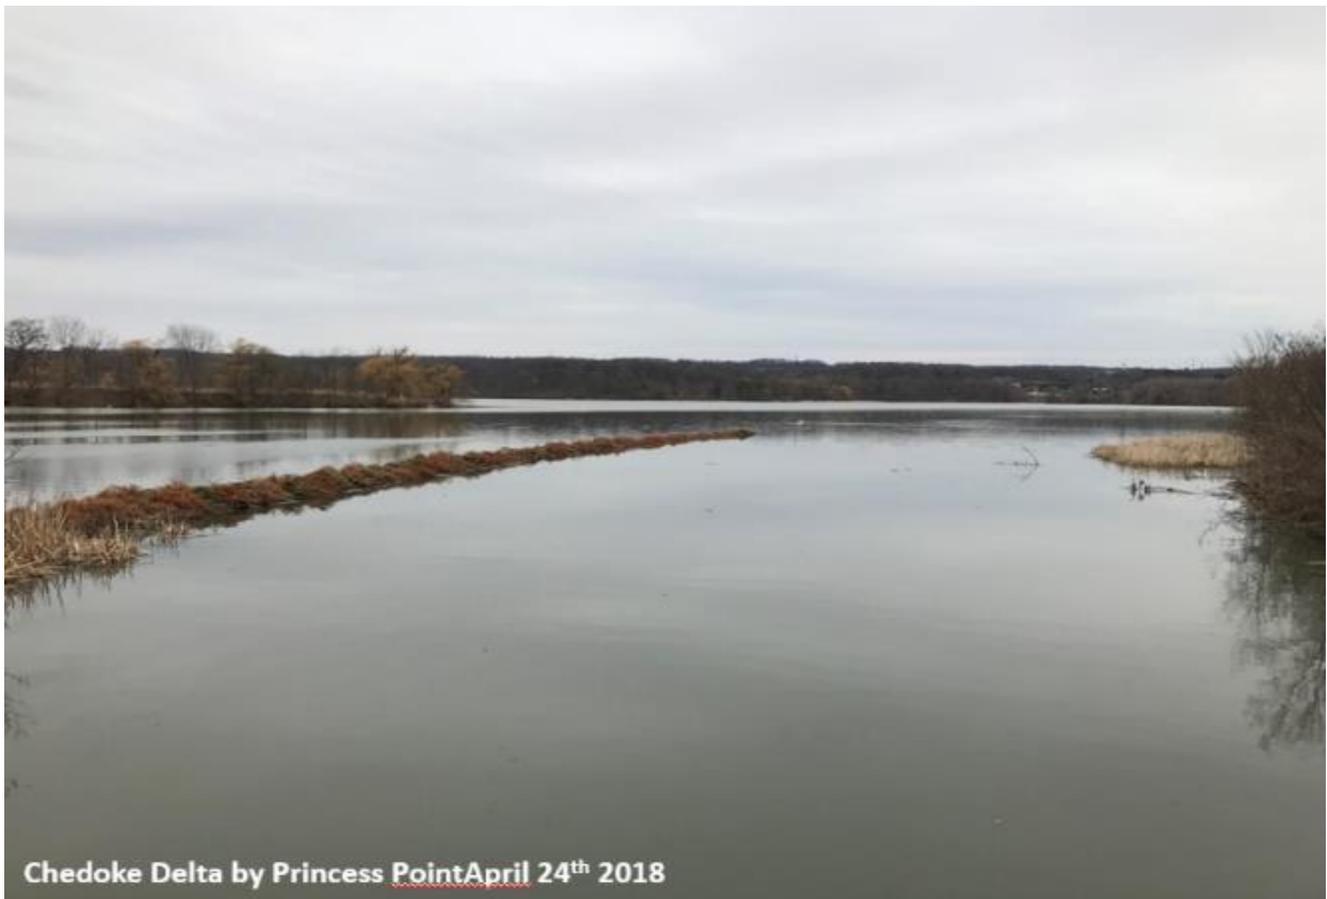
Figure 8. Christmas tree berm in the delta of Chedoke Creek, Cootes Paradise Marsh as interim deflector of the creek water

2018 –RBG initiates development of a protection berm in Princess Point Bay in January, to divert polluted waters away from Princess Point public access point, as per the RBG 2016-2021 Restoration Plan (with funding support from Environment and Climate Change Canada).

2019 –RBG continues to develop protection berm in Princess Point Bay to divert polluted waters away from Princess Point public access point, as per the RBG 2016-2021 Restoration Plan.

2019 – From May to September, RBG undertakes water quality monitoring program to assess the effectiveness of the berm at diverting Chedoke Creek water past the Princess Point Bay.

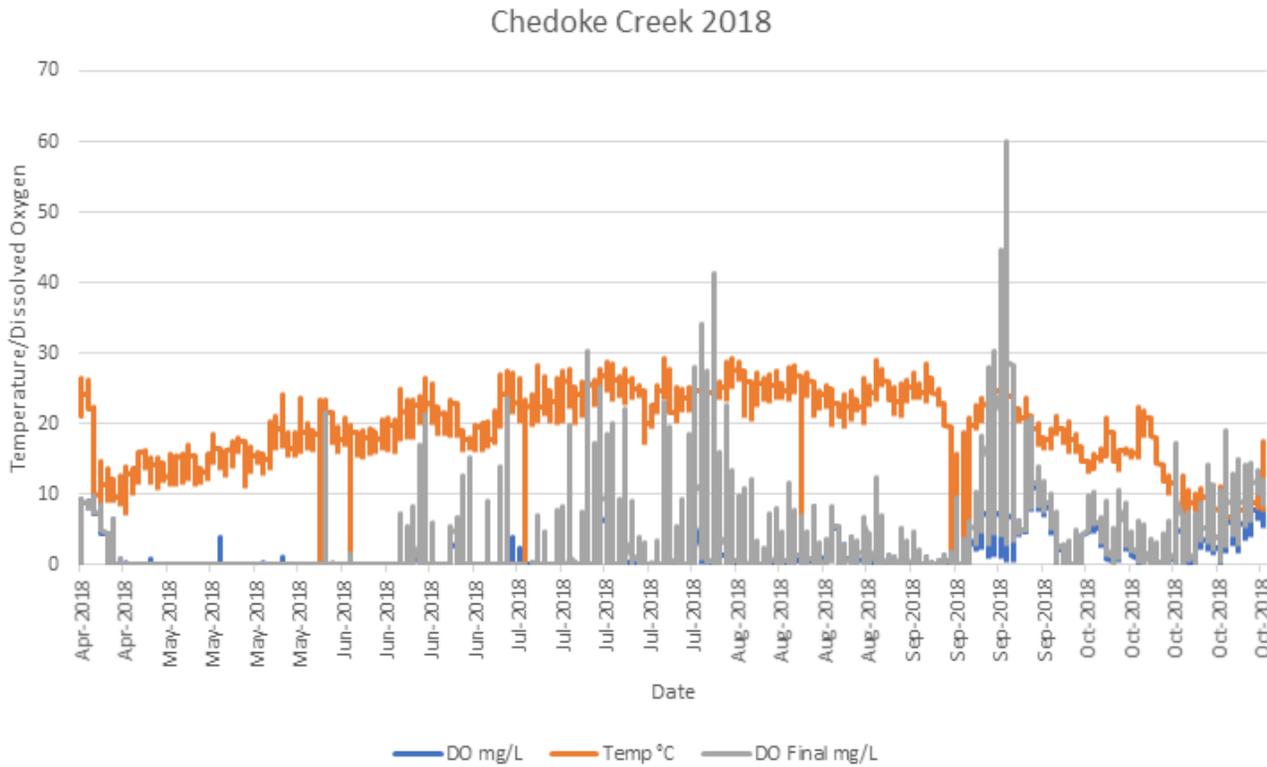
Figure 9. 2018 Dissolved Oxygen profile for Chedoke Inlet of Cootes Paradise Marsh illustrating anoxic conditions

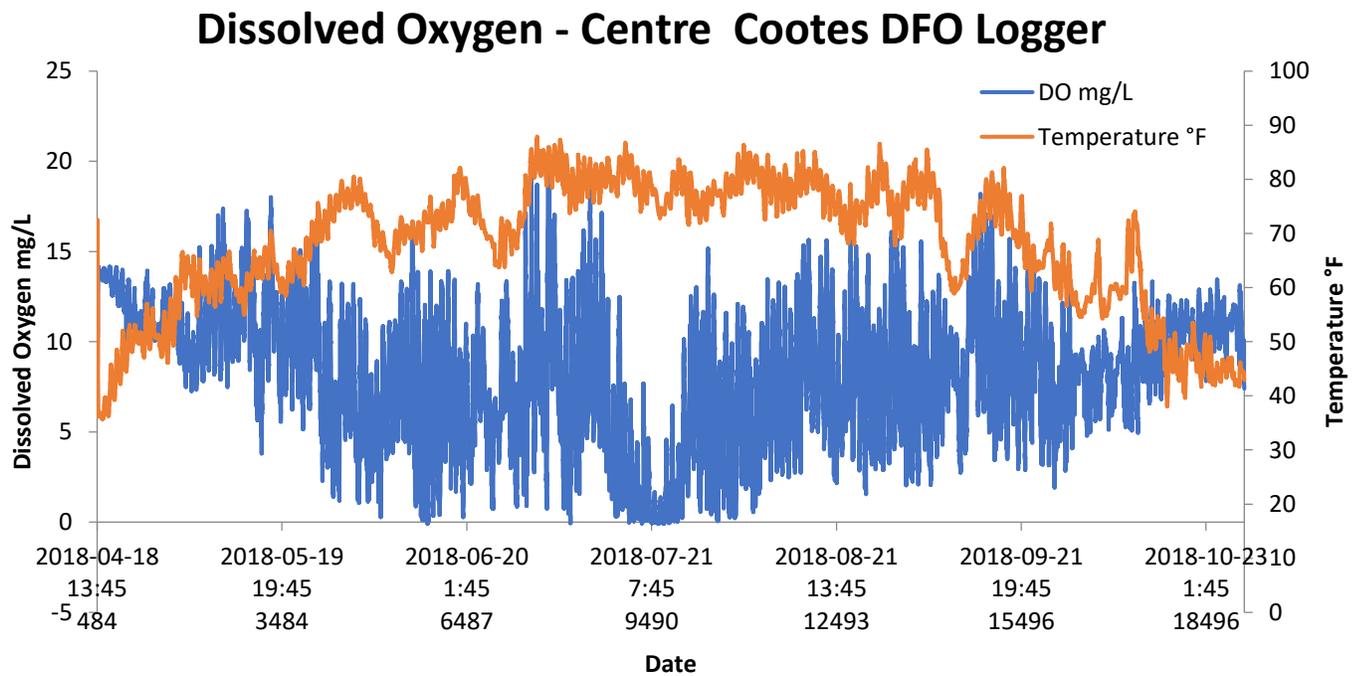
Figure 10. 2018 Dissolved Oxygen profile at the centre station of Cootes Paradise Marsh illustrating near anoxic conditions

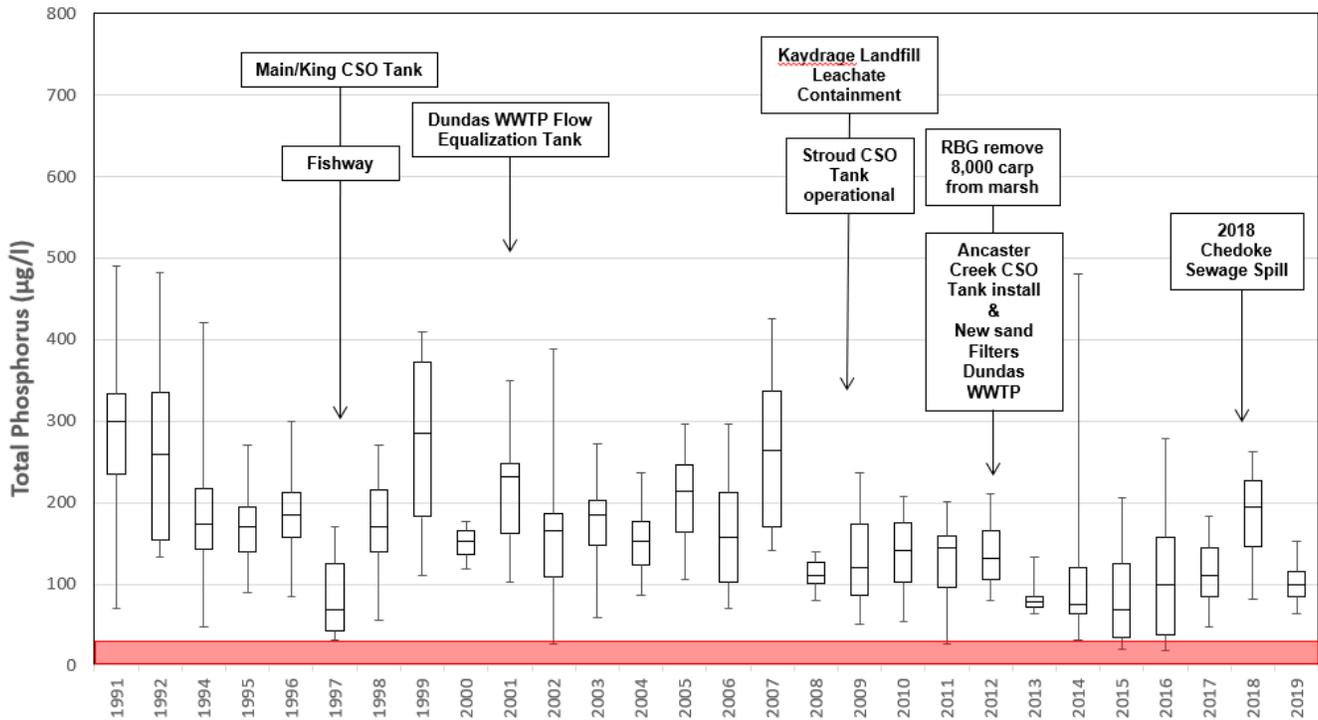
Figure 11. Total Phosphorus trend at the centre of the marsh. The centre station serves as the HHRAP target index station, illustrating the effect of the spill in circulating within main water area of the marsh. Chedoke Spill 2014-18.

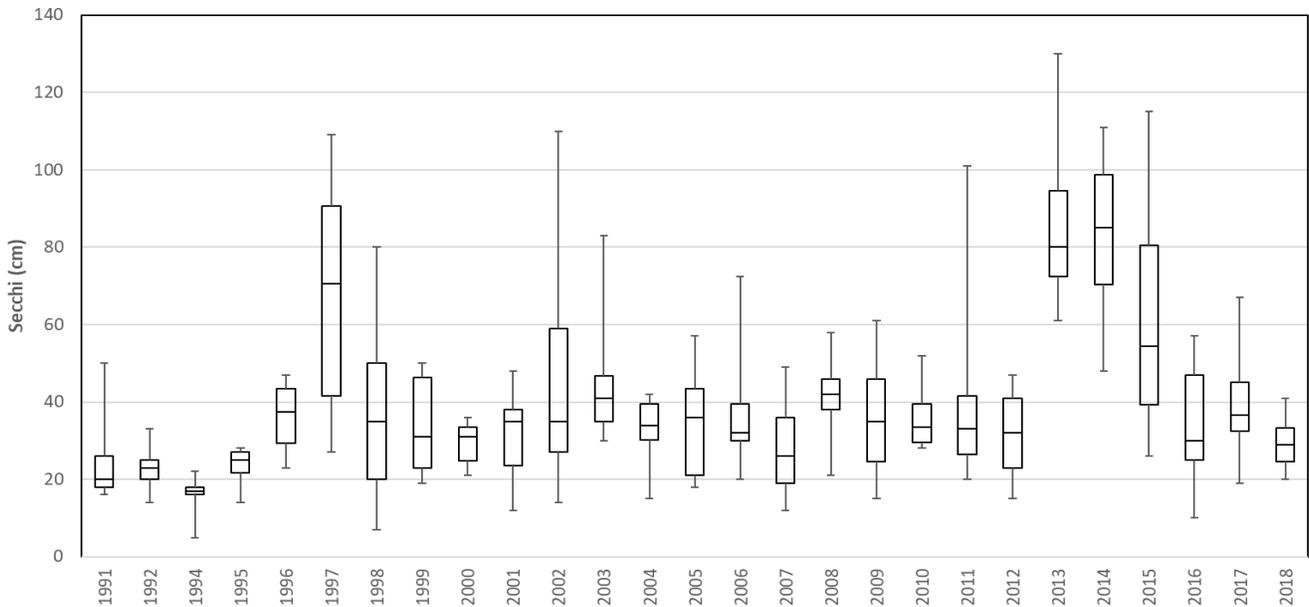
Figure 12. Water Clarity long term trend at the centre of the marsh. Chedoke Spill 2014-18.

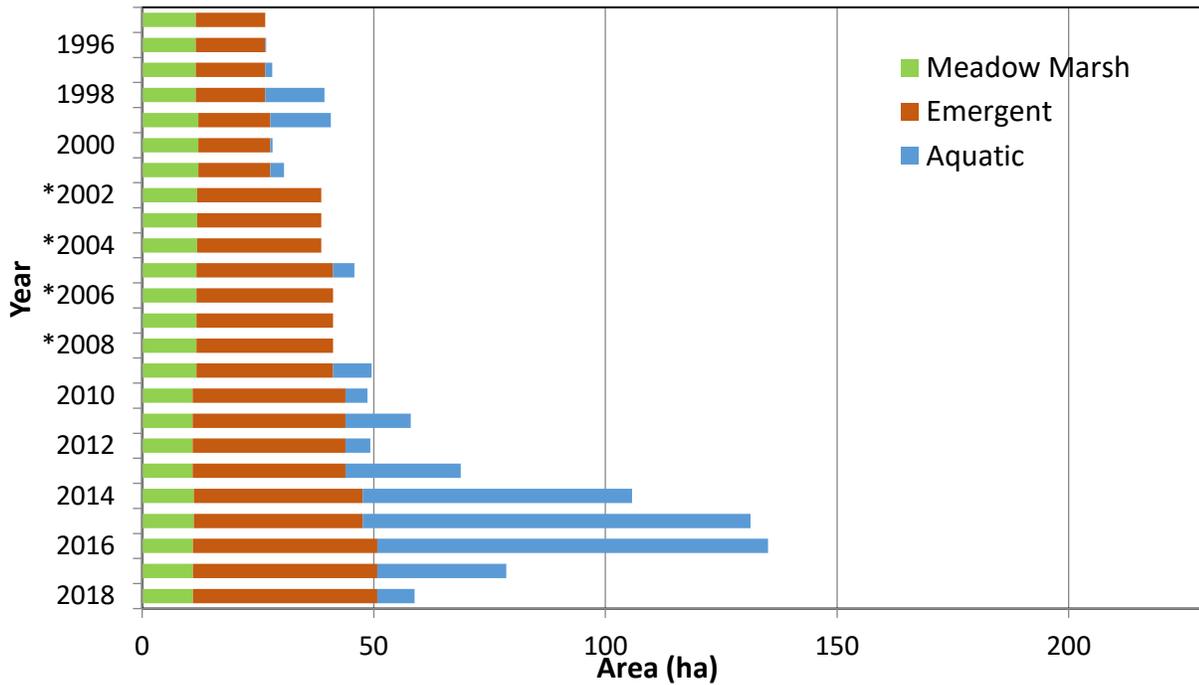
Figure 13. Aquatic Vegetation Coverage Trends in Cootes Paradise 1996-2018.

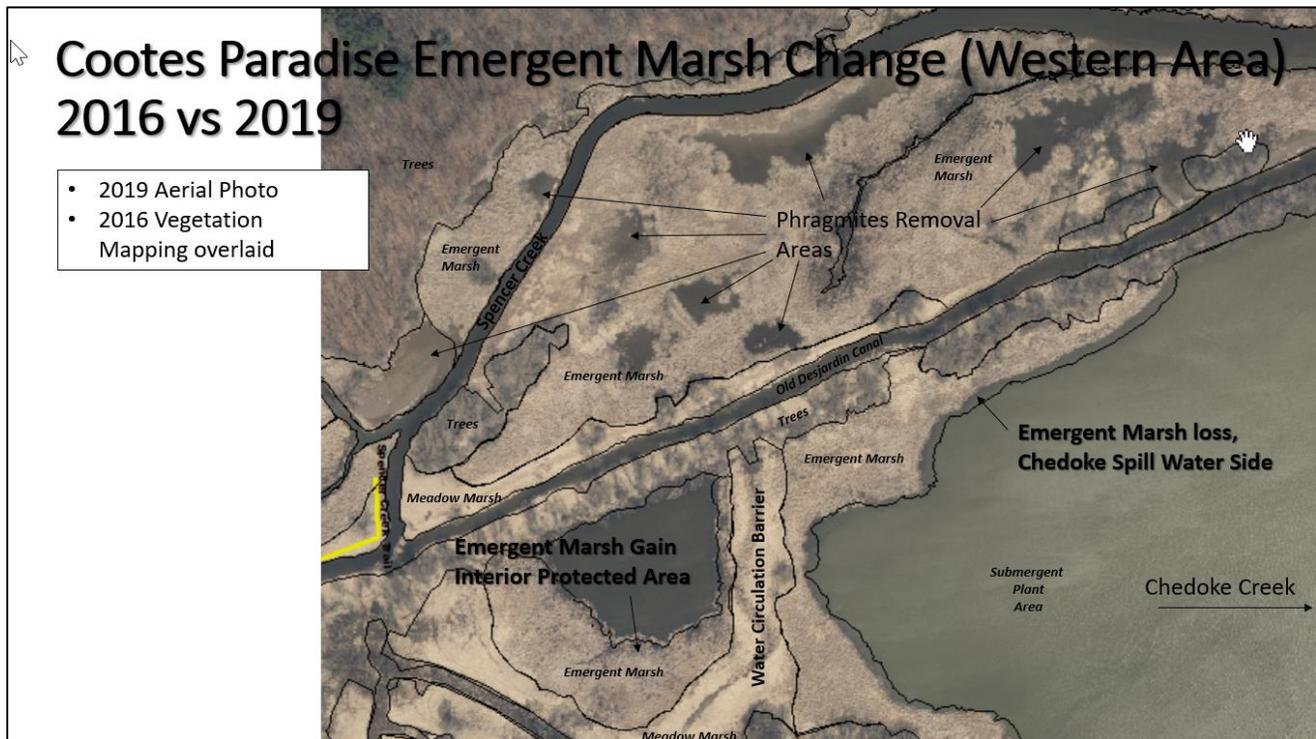
Figure 14. Emergent Marsh Mapping - 2016 Mapping overlaid on 2019 Aerial Photo showing loss of cattails

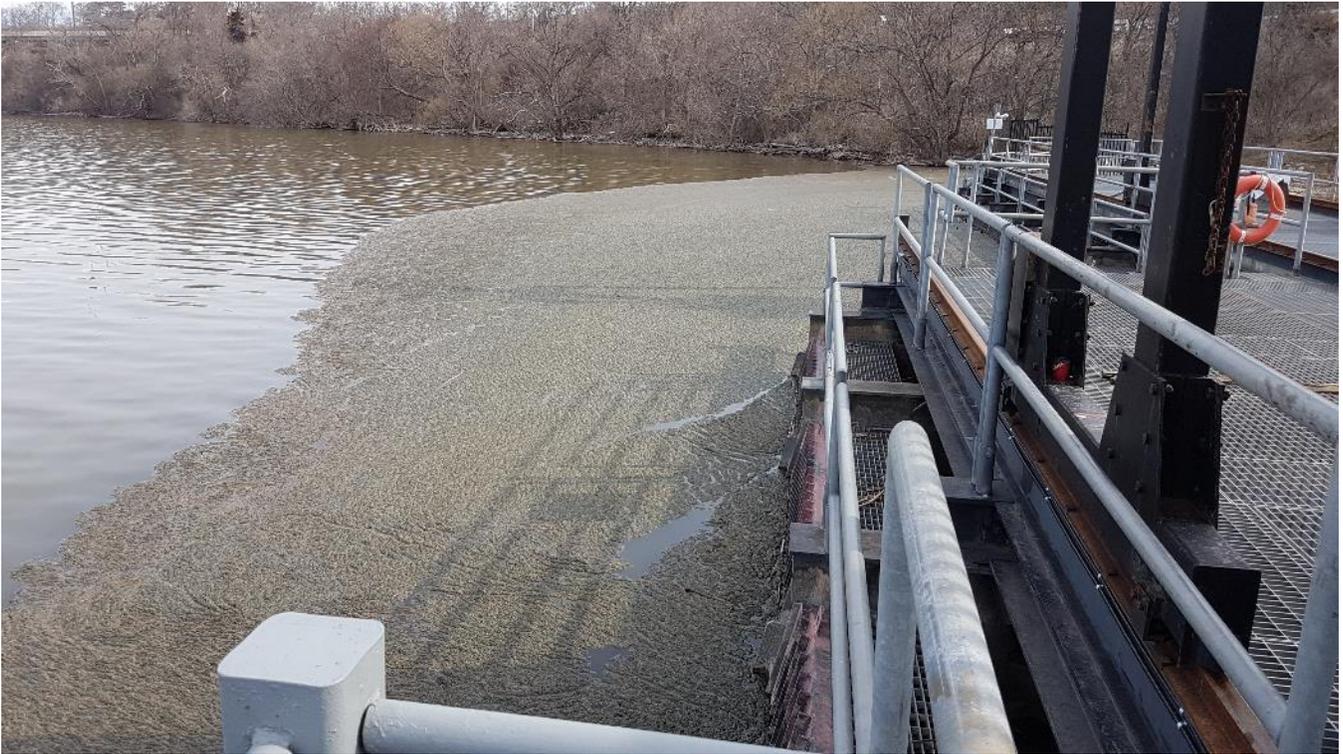
Figure 16. April 20th Algae accumulation issue at the Fishway (like most years prior to 2018 at the Fishway).

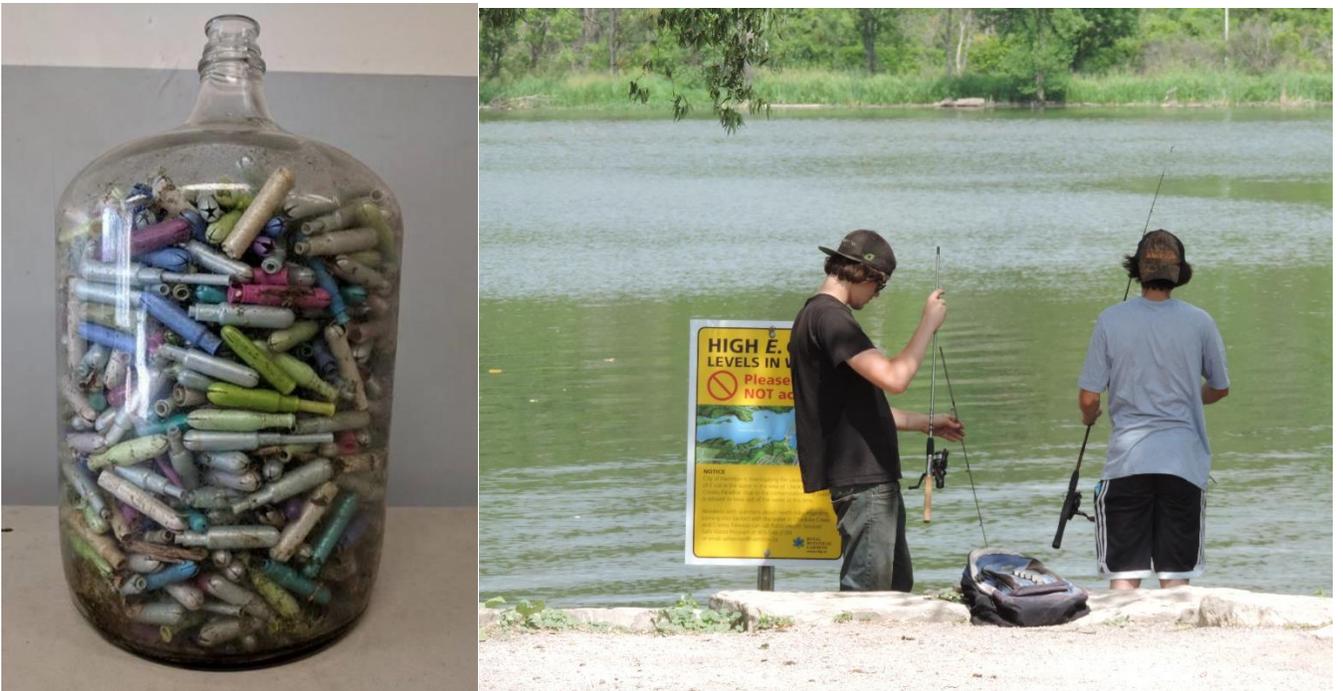
Figure 17. Pictures of Stewards of Cootes Volunteers clean-up efforts from August work along the flooded Desjardins Trail and children fishing at Princess Point by the warning sign.

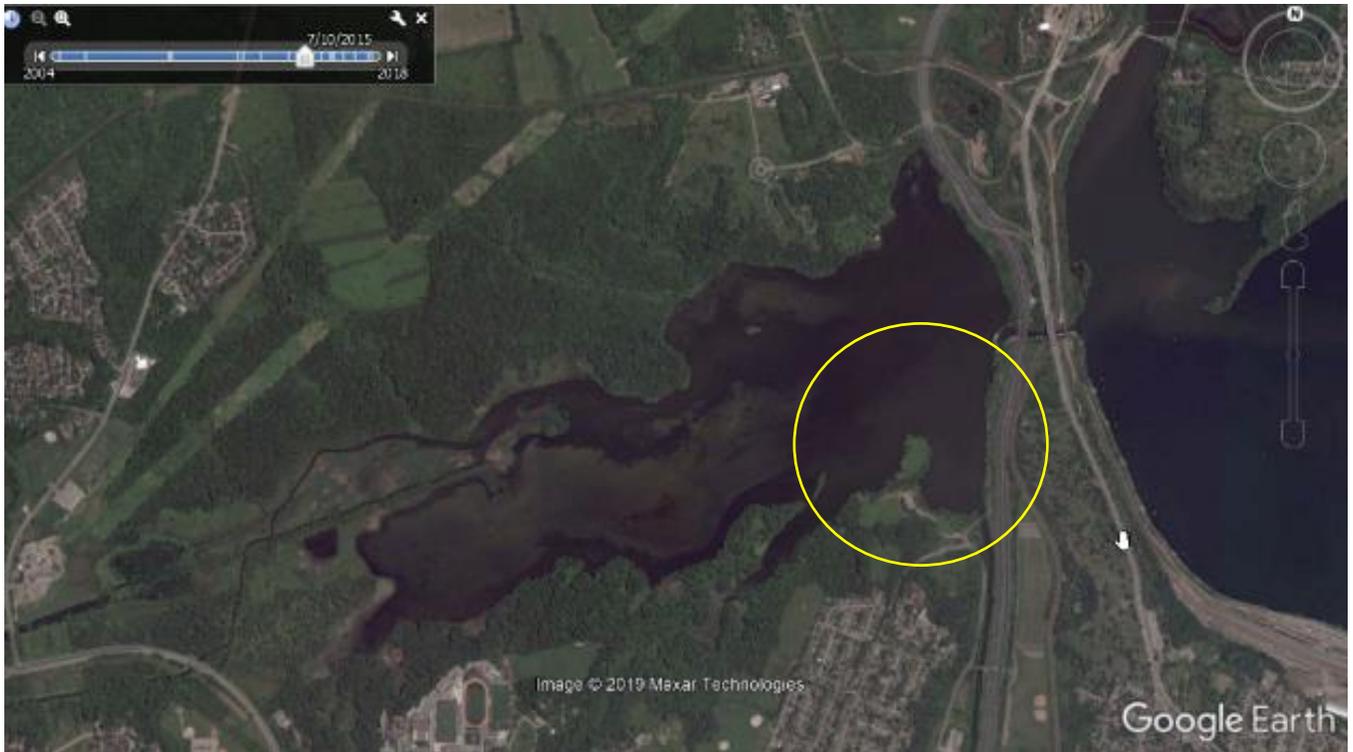
Figure 18. July 10, 2015 Google Earth aerial photo (Photo used in RBG Wetlands Restoration Plan, 2016-2021). Marsh clear and with aquatic plants (other than algae bloom in waters downstream of Chedoke Creek).

The impacts to Royal Botanical Gardens were diverse and extensive as Cootes Paradise Nature Sanctuary is the largest and central property of RBG property. Effects range from ecological damage and contamination of the bed of the marsh, loss of planted emergent plants associated with decades of intensive marsh restoration work, public access management, as well as revenue-loss associated with lack of access and RBG programming. The ecological damage was driven by a doubling of phosphorus concentrations throughout much of the marsh in 2018. This resulted in intense algae blooms that smothered aquatic life and left the water depleted of oxygen. These effects are illustrated in the pictures and graphs included in this document that summarize monitoring work undertaken in support of marsh restoration. The effects are notable starting in 2014, but there was a general collapse of the marsh aquatic plant community that occurred in summer 2016. Similar impacts are noted at the water quality monitoring station at the mouth of nearby Grindstone Marsh in 2018 but are not included in this report. The spill effects are also clearly visible in the aerial photos obtained for July 2015 & 2018 (Figure 18, Figure 19).

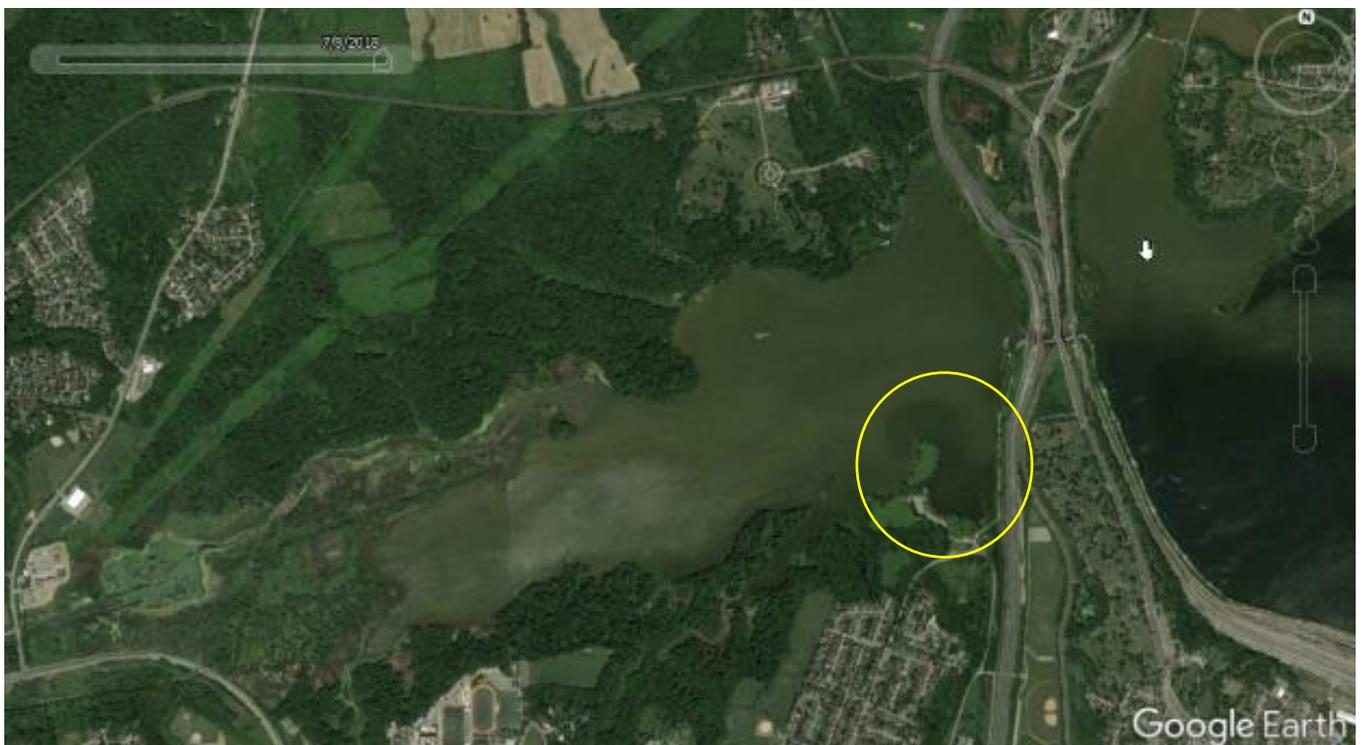
Figure 19. July 7, 2018 Google Earth aerial photo – all Cootes Paradise is an algae bloom as water mixes; unmixed Chedoke inflow is notable by Princess Point.

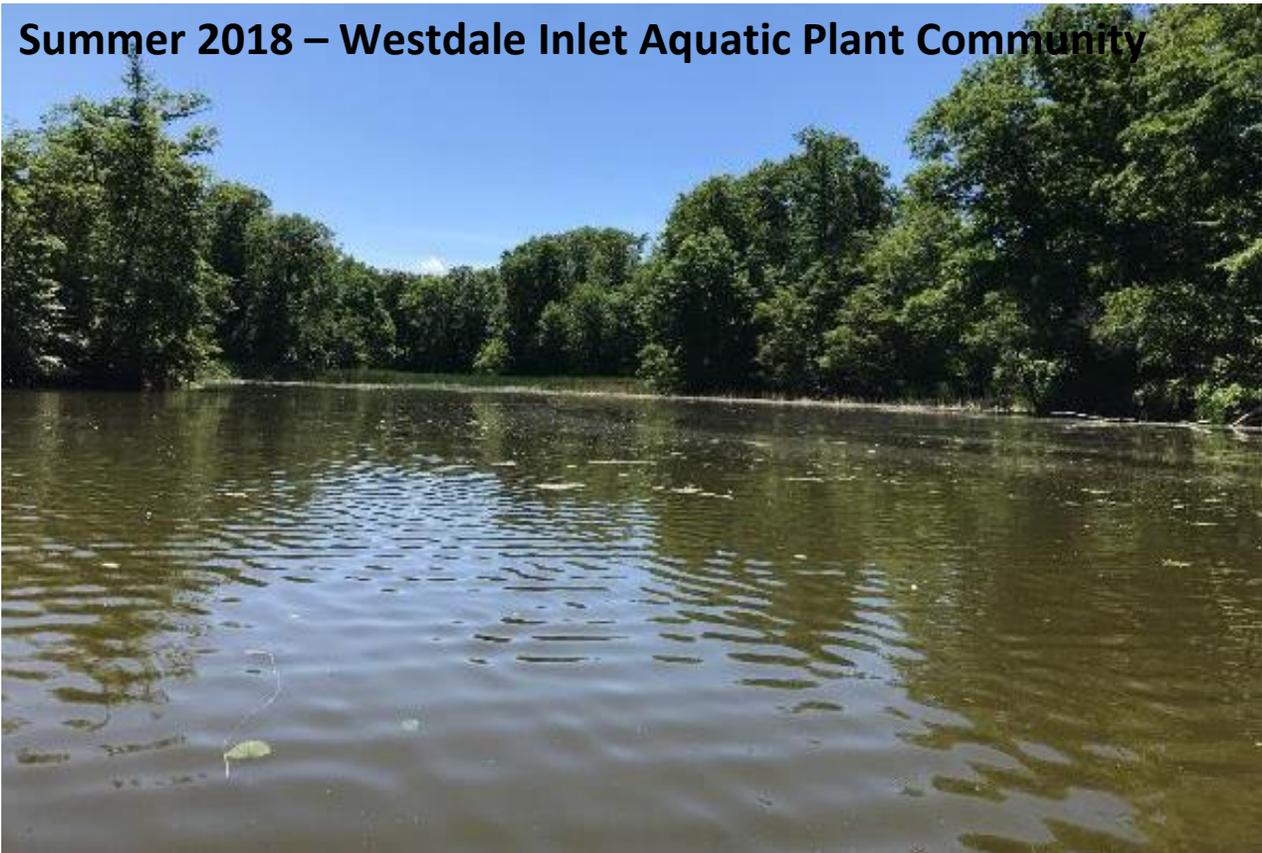
Summer 2018 – Westdale Inlet Aquatic Plant Community

Figure 20. Pictures illustrating plant community decimated in Westdale Inlet area of Cootes Paradise

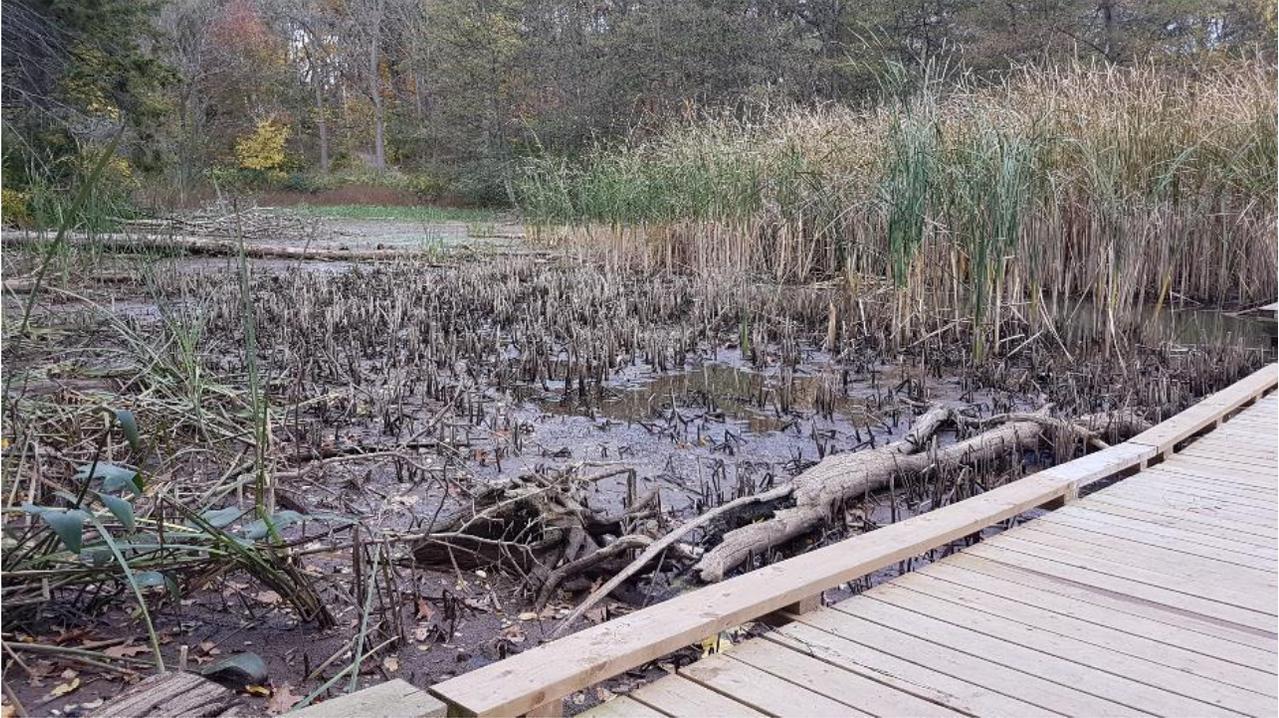
Figure 21. Example area where emergent vegetation (bur-reed & cattails) was lost to algae and high water near the RBG Boathouse at Cootes Paradise. October 2017 photo following a water level decline of ~90cm.

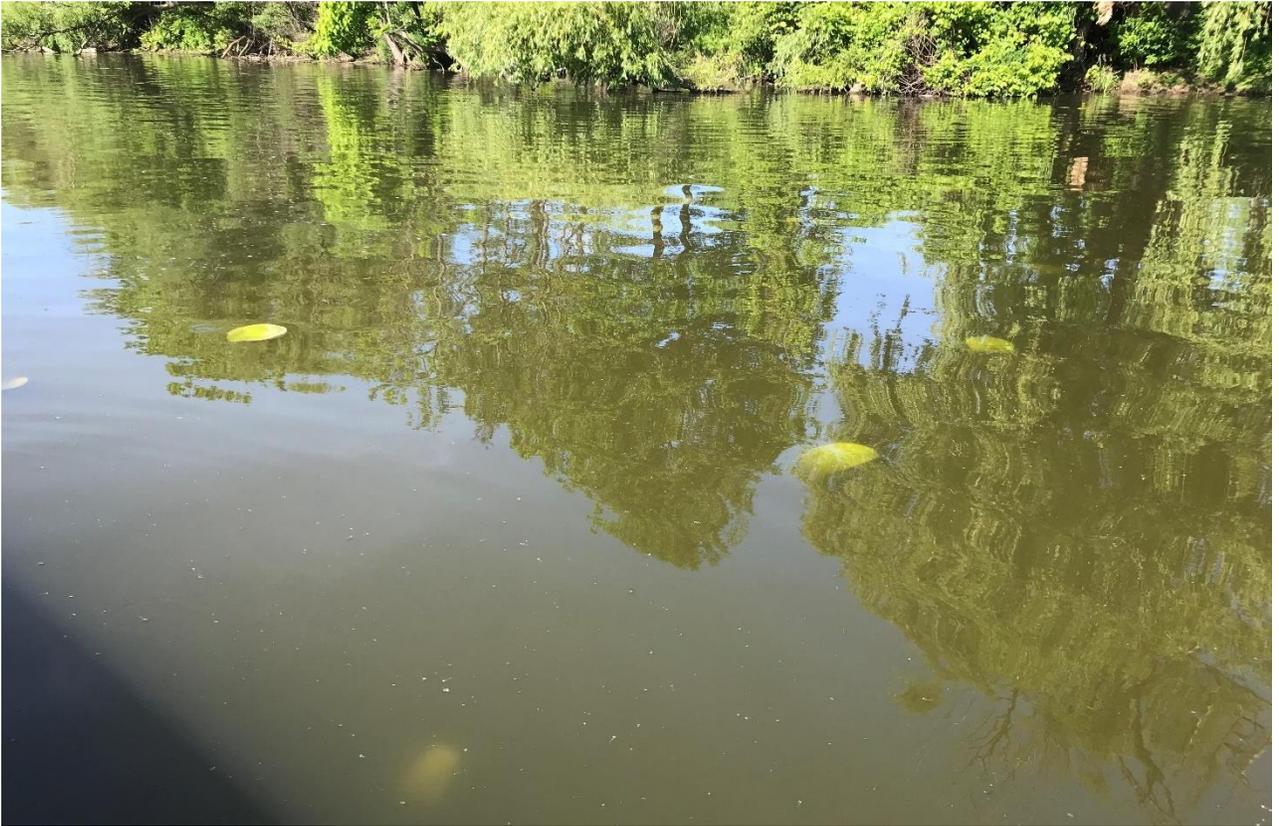
Figure 22. Water lilies attempting to grow through the early algae blooms in May 2018.

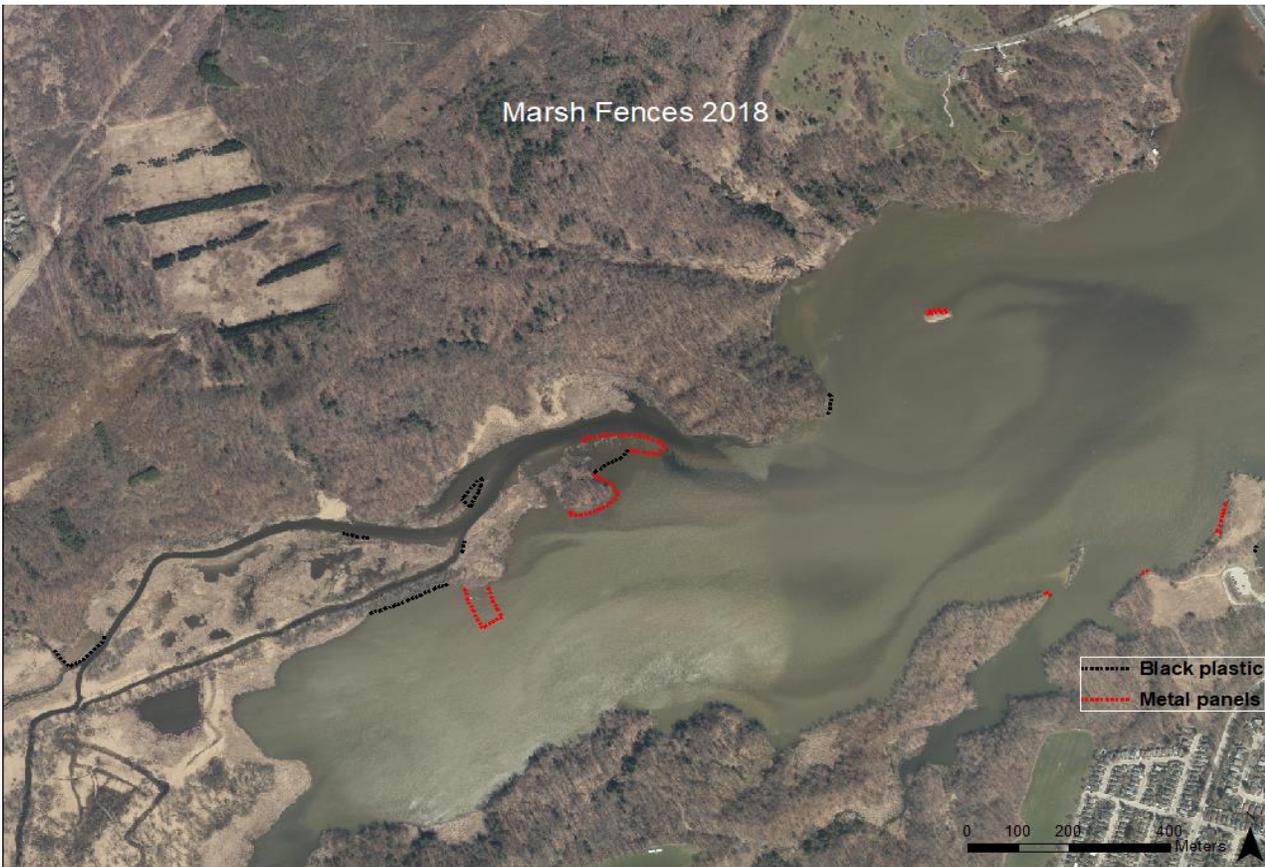
Figure 23. Cootes Paradise Marsh Planting Herbivory/wave protection fence locations in 2018. Total length 1.5km
