Impact to Cootes Paradise Marsh associated with Chedoke Creek spill of 2014-2018

Tys Theijsmeijer
Natural Lands Department
Royal Botanical Gardens
February 20, 2021

Executive Summary

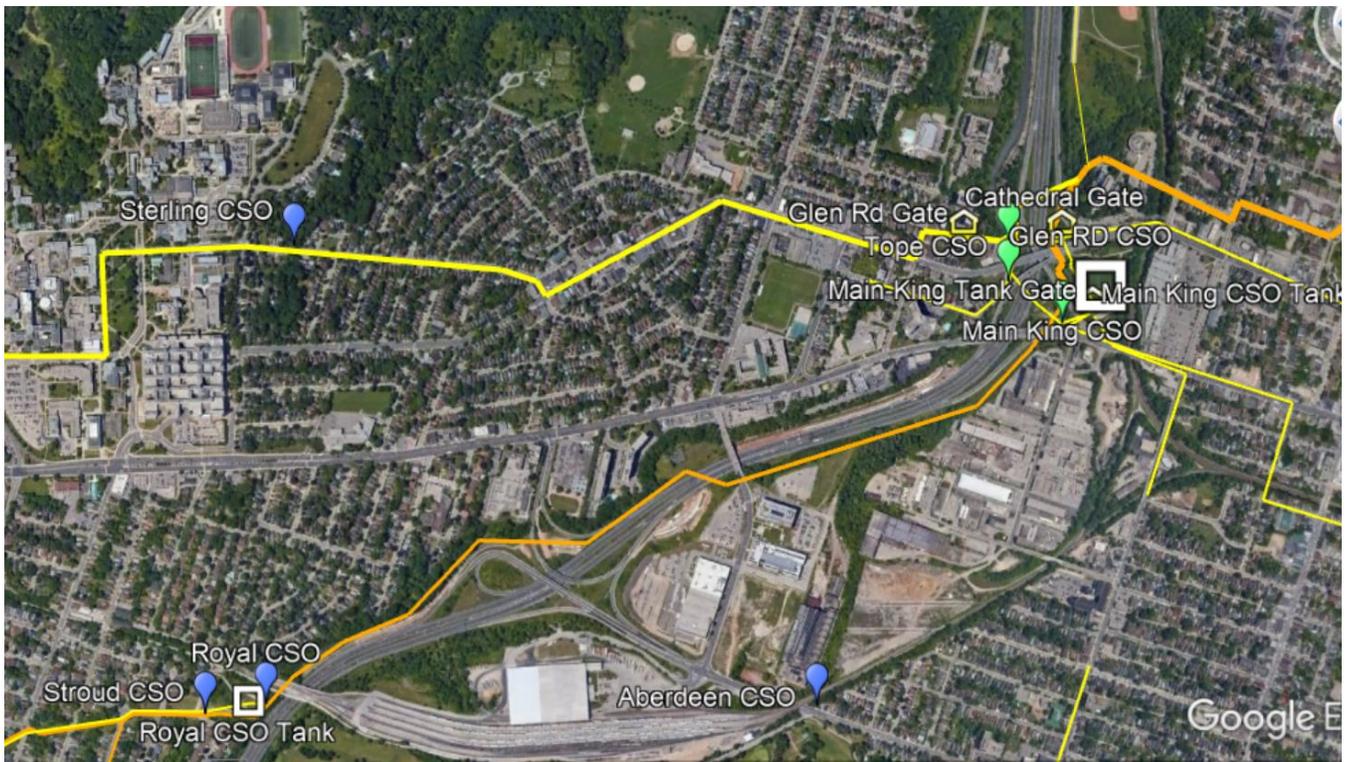
Figure 24. Main King Sewer Control System Area as transposed from the Hamilton online maps portal.

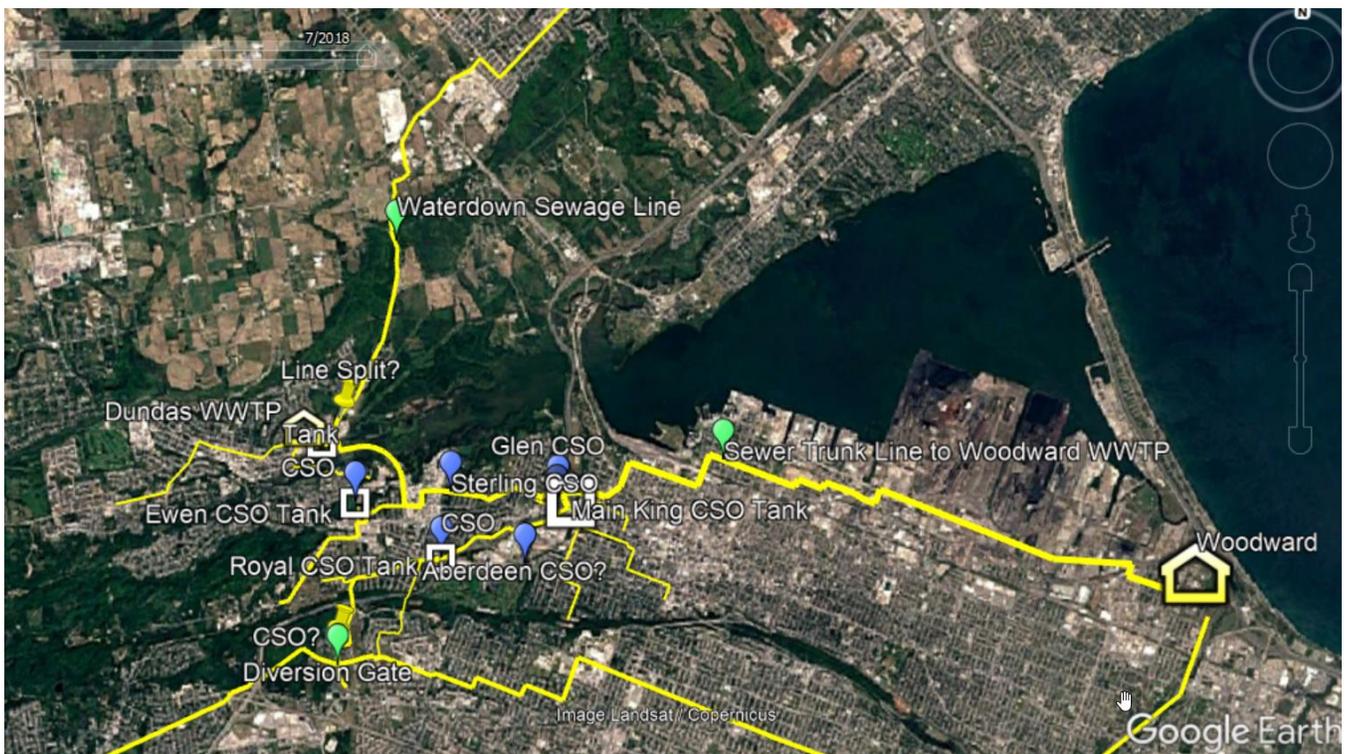
1. Dundas Diversion Tank (this has never occurred to date)
2. Westdale – Sterling CSO point
3. Glen Road CSO point
4. Main King CSO point

In addition, a diversion point from on top of the escarpment in Ancaster to one of the sewer lines following down Chedoke Creek's west branch, diverts excess flow in the escarpment trunk sewer lines to the Main-King CSO tank.

Figure 25. Basic Layout of the Sewage Control System as transposed from Hamilton online maps portal.
