2023 Marsh Status

Marsh Restoration Progress

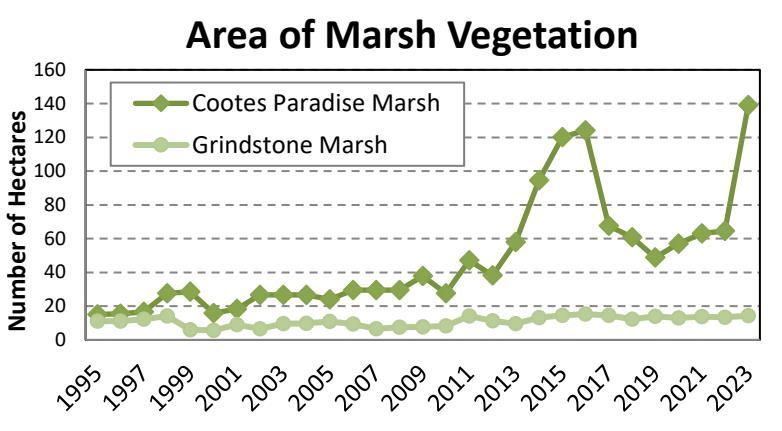
Marsh Vegetation Trends

In a healthy marsh, water level fluctuations create the pattern of submergent, emergent and meadow marsh plants. By 1990 virtually all submergent and emergent plants were lost from Cootes Paradise Marsh, the water was hypereutrophic, muddy, and ecosystems had collapsed, with attempts of carp management abandoned. Grindstone Marsh was only in slightly better condition, with patches of plants found only in the outer marsh. A century of inflowing sewage, watershed erosion and invasive species had destroyed them. In 1997 through the RAP a new barrier to exclude large carp became functional at the entrance to Cootes Paradise. A barrier for Vallev the Inn area of Grindstone Marsh was never installed. RBG constructed an alternate system in the area, completed in 2001. The unprotected area of the marsh no longer hosts marsh plants.

Since 1997 Cootes Paradise aquatic plant growth varies from year to year. Extensive rafts of algae still overwhelm the plants, from the excess nutrients inflowing. The common species change by season. In spring 2023 the pondweeds Stuckenia pectinata and Potamogeton crispis were most common, while in summer Myriophyllum spicatum and Ceratopyllum demersum were common. White Waterlily (*N.tuberosa*) covered ~4% of marsh. Wild rice (Z.aquatica) also grew in several localized areas.

In Grindstone Marsh's carp excluded areas submergent aquatic plants were variable. White Waterlily dominates covering ~20% of the area, with 18 plant species present. A small number of wild rice grew in some of the meadow marsh area ponds. In the outer marsh by Carroll's Bay where carp are not excluded and excess sediment flows in, only one small patches of white water lily remains. Emergent plants in carp protected areas thriving and increased dominated by cattails (Typha sp.) and Giant Burreed (S.eurycarpum).
